A Correlative Workflow for Characterization of Interconnects in Advanced Packages

Originally Published at ISTFA 2022: Proceedings from the 48th International Symposium for Testing and Failure Analysis Conference

A Correlative Microscopic Workflow For Nanoscale Failure Analysis and Characterization of Advanced Electronics Packages

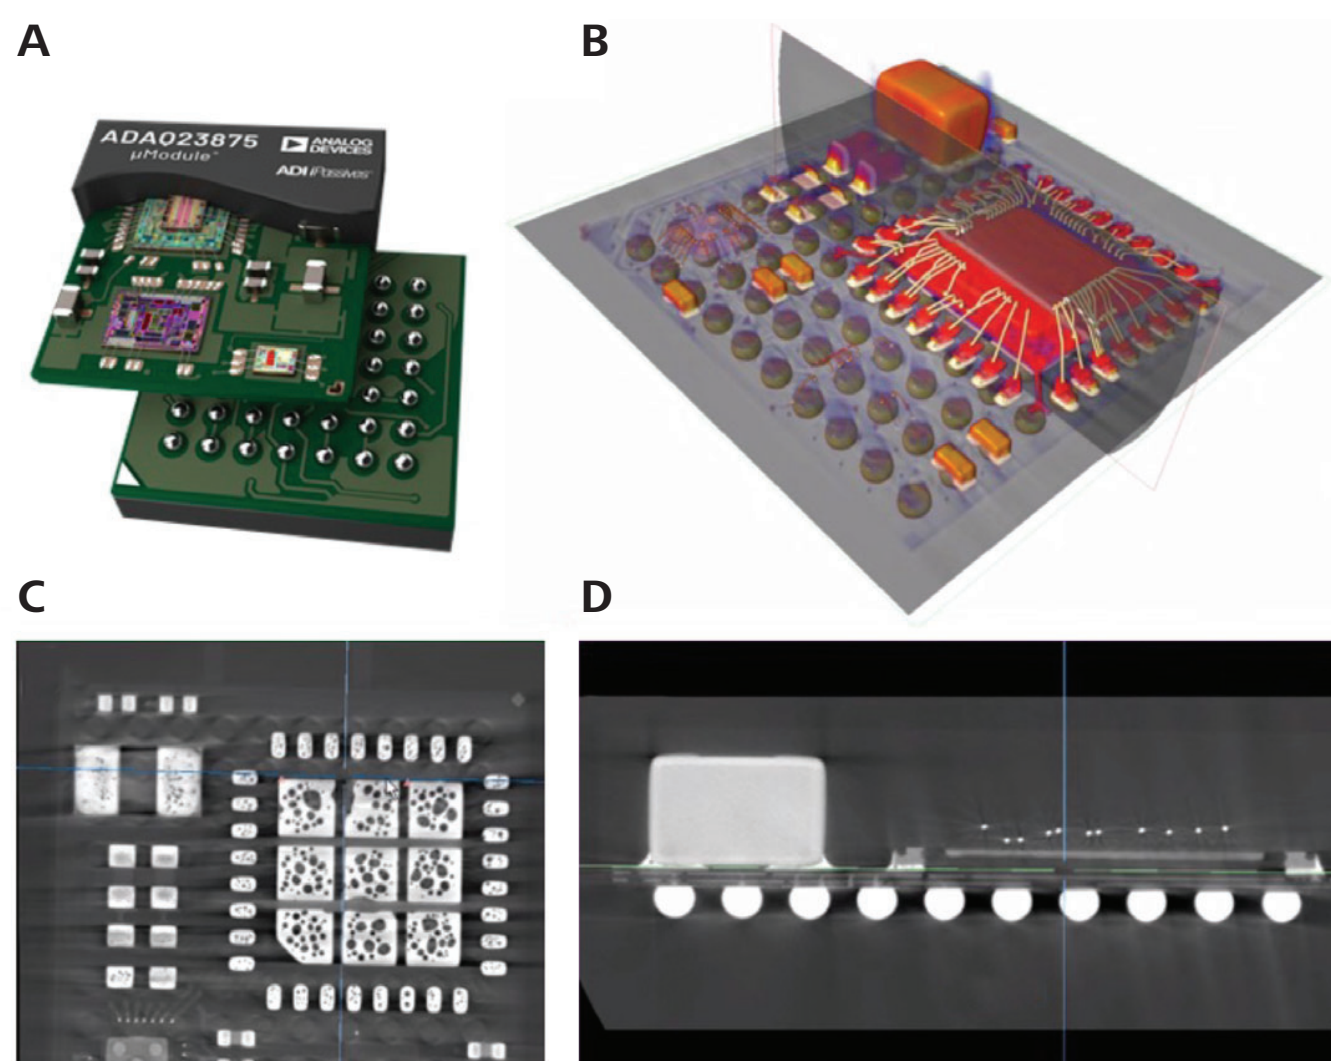
A commercially available ADAQ23875 system-in-package (SiP) device was purchased using a standard commercial channel. The sample was overstressed with excessive current provided by a Keithley probe station. The test stopped when 100X decrease in current was observed in I-V curves. The sample then was imaged by 3D X-ray microscopy at 10 μm/voxel resolution to capture full field of view (FOV) of the package. 120 kV X-ray energy was used to image this medium density sample. A high-resolution image at 1.5 μm/voxel was acquired. Figure 1 shows the 3D color-rendering image and examples of reconstructed virtual slices.

Figure 1 3D X-ray tomography compared to schematic. A) Schematics of dissected SiP (marketing material) suggest the internal chips and electric net design. B) 3D color-rendering of acquired tomography shows internal wire bond networks in this study. C-D) examples of virtual cross-sections.

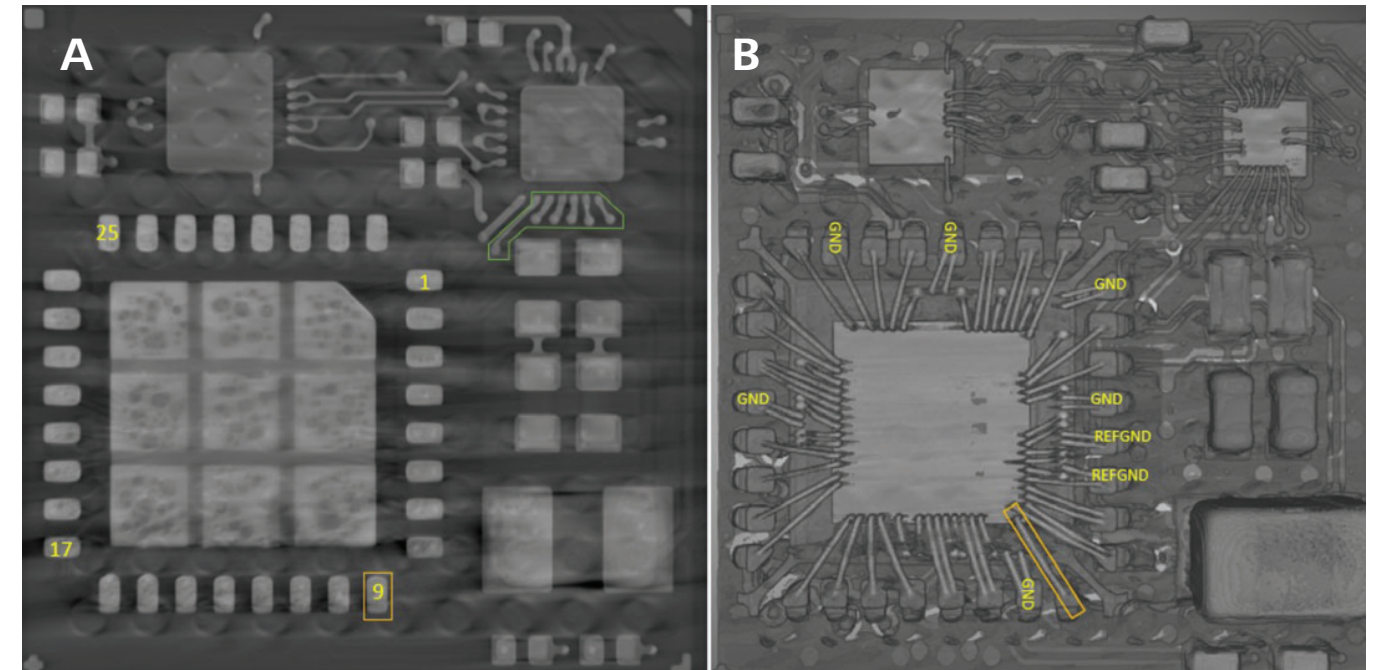
The XRM data was processed using analysis workflows within ORS Dragonfly to "digitally" remove encapsulating packaging material and reveal the internal components of the SiP, including the gold wire bonds, ICs, passive components, and the underlying PCB substrate. In Figure 2, specific electric networks of interest with the suspicion of partial wire opening (associated with excessive resistance) are labeled on the planar views of the XRM images. The flexibility of 3D digital data manipulation makes it easy to visualize the internal structures at any orientation.

Figure 2 The electric networks of interest with the suspicion of partial open (high resistance) are labeled on the planar views of 3D XRM images: A) bottom side view of the ADC (LTC2387-16). B) top side view.

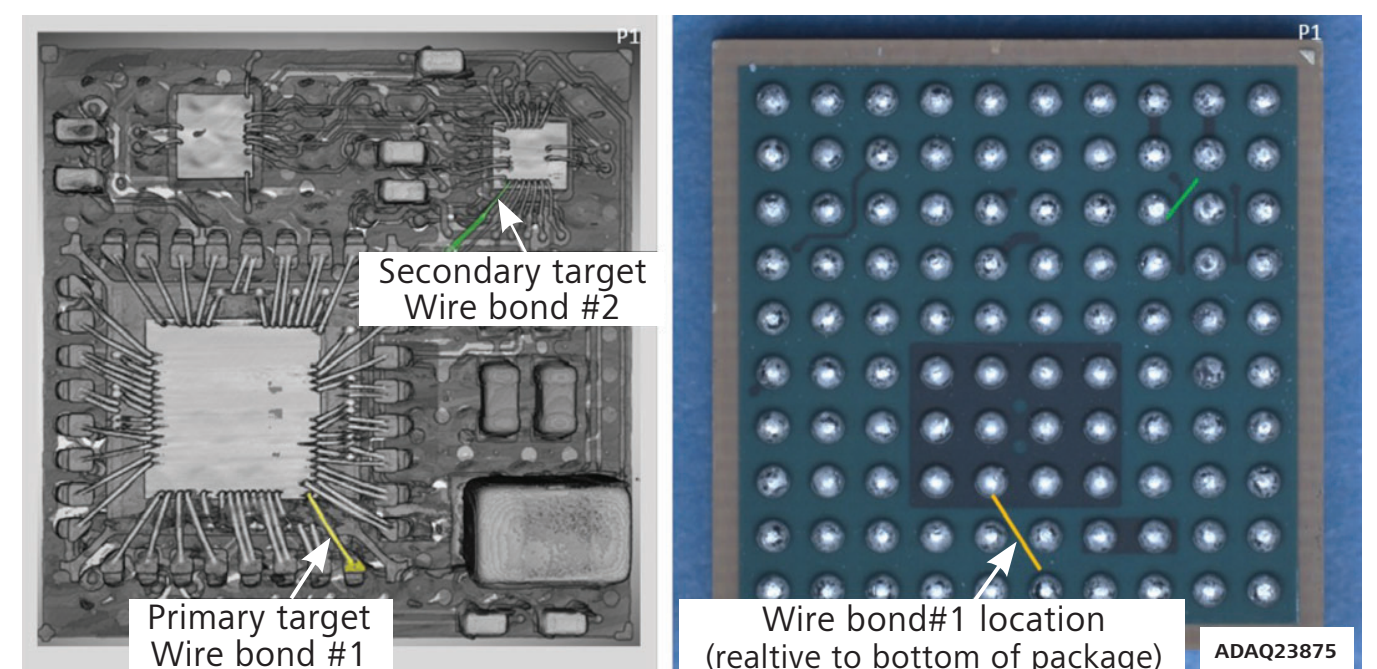
Having selected a wire bond arc of interest (the primary target wire bond #1 in Figure 3), the sample was then cross-sectioned using the propriety Perfect Edge process which combines a mechanical cutting step and inert gas plasma polishing. This process flow was developed to enable key micro-structural information to be extracted from samples with speed and accuracy, allowing us to target features within packages such as the SiP package studied here. Because the X-ray images provide excellent interior 3D information, there is no need for de-encapsulation prior to the physical cross-section. The process allows us to minimize artifacts, optimize preparation process, and increase positioning accuracy, making it possible to reliably target features with the accuracy down to submicron. Figure 4 shows the cross-section SEM image of the target Au wire with the assistance of the XRM image (Figure 4 top). The entire gold wire loop is accurately sectioned and undamaged between ball and wedge bonds.

Figure 3 Two target leads (labeled as yellow and green) were chosen in this study for demonstration purpose. The wire bonds lie at an oblique angle to the edge of the package. The photo on the right shows the positions of these two wires on an optical image.

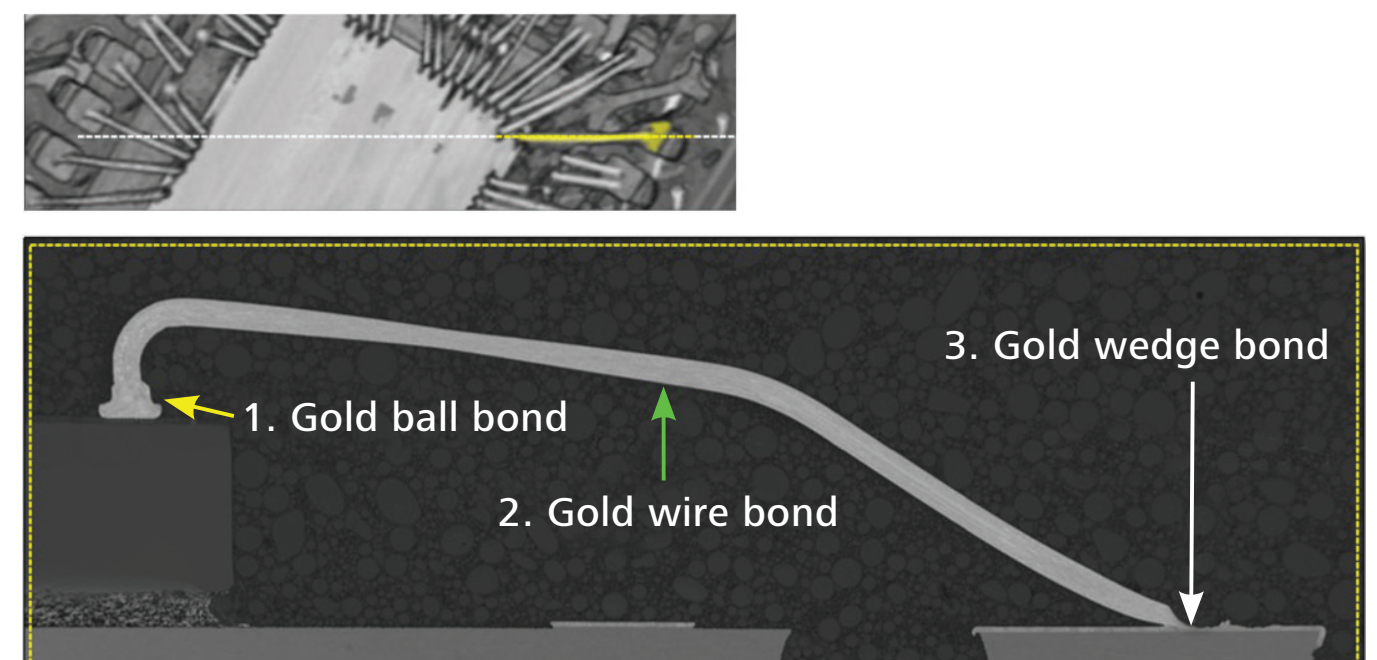
Figure 4 An XRM virtual cross-section (top) and SEM image (below) show the entire targeted wire bond. The sample was analyzed to confirm the condition of electrical connectivity. The gold wire loop is undamaged between ball and wedge bonds.

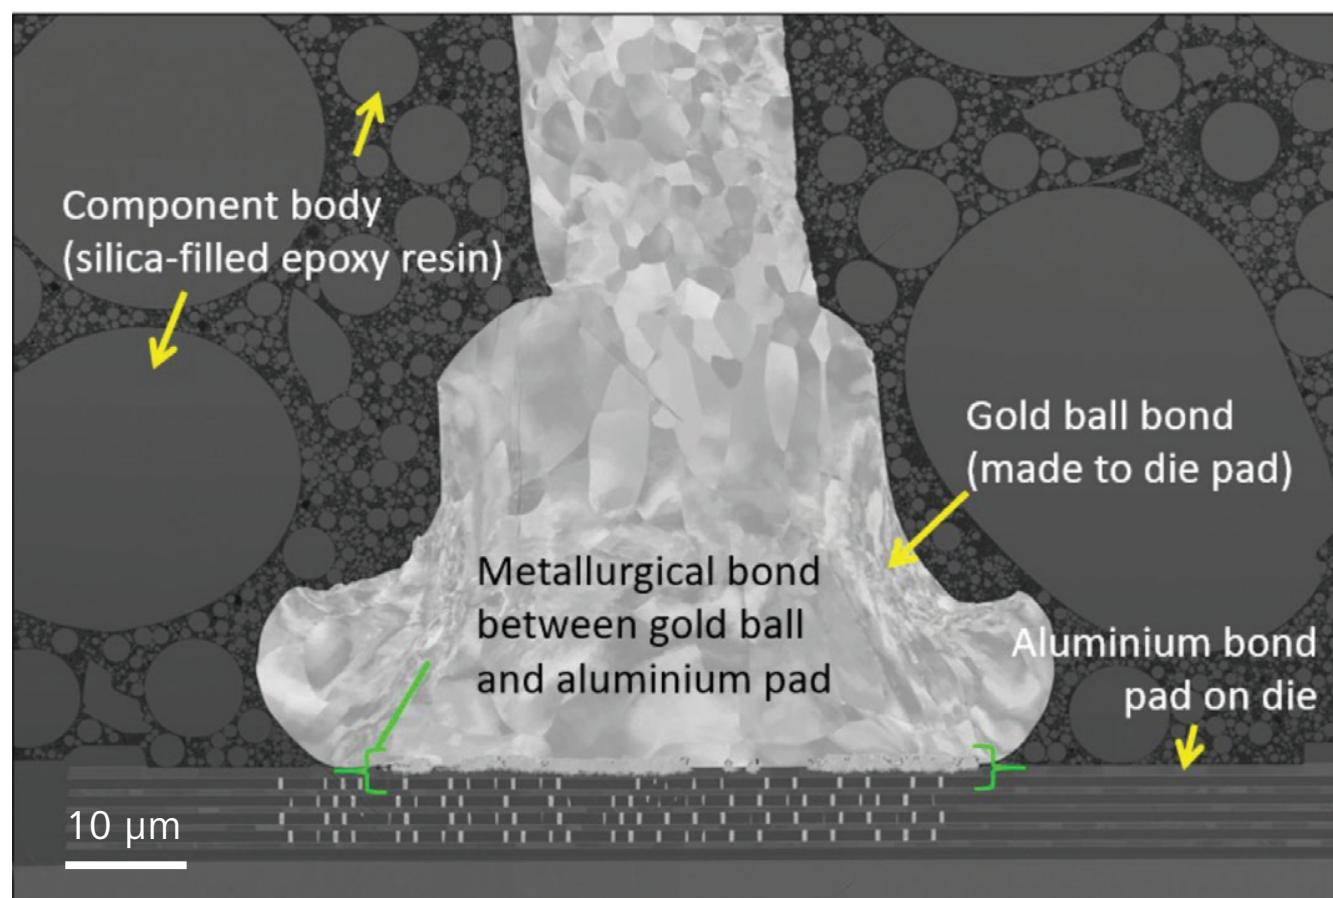
Because the Perfect Edge process provides a large surface free of contamination and distortion, we are able to acquire high-quality SEM images which reflect unaltered sample conditions. Figure 5 shows the ball bond made between gold wire and aluminum bond pad on the die. The moulded component body, wire bond and die are all clearly visible. Figure 6 shows that several phases of the intermetallic compounds (IMCs) were formed at the interface of the gold ball and the aluminum pad. IMCs provide physical and electrical connection between the wire and die. These IMC phases were further analzyed by Energy Dispersive Spectroscopy (EDS) in Figure 7. A thin layer of aluminum oxide (blue arrows in Figure 6-7) was formed between two IMC phases. A high-magnification image further confirms the oxide-rich region in Figure 8. We believe that this oxide layer could be the root cause of the excessive resistance observed during the overstress test, which is consistent to the report [6]. A further investigation is required to confirm that the oxide growth is responsible to the high resistance of the Au wire loop. As the main topic of this work is to develop the correlative sample preparation and imaging workflow, we continue to focus on the workflow.

Figure 5 Ball bond made between gold wire and aluminum bond pad. The moulded component, wire bond and die are all clearly visible. A metallurgical bond was formed between the gold and the aluminum during device manufacturing. This provides physical and electrical connection between the wire and die.

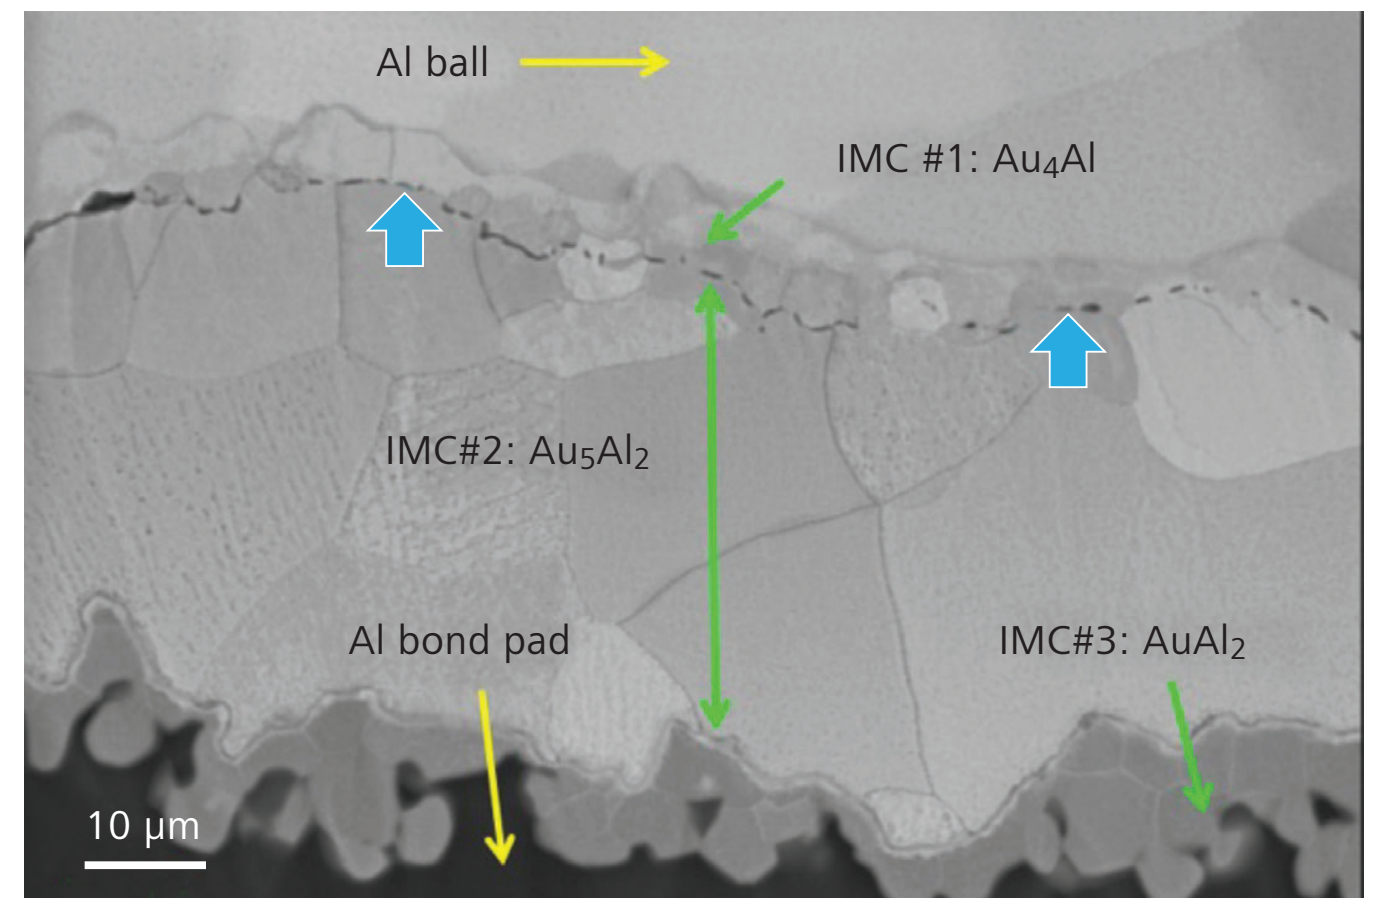
Figure 7 Ball bond made between gold wire and aluminum bond pad. Several Au-Al IMC phases have formed. Energy Dispersive X-ray (EDS) analysis was used to identify the IMC phases (labelled here for reference).

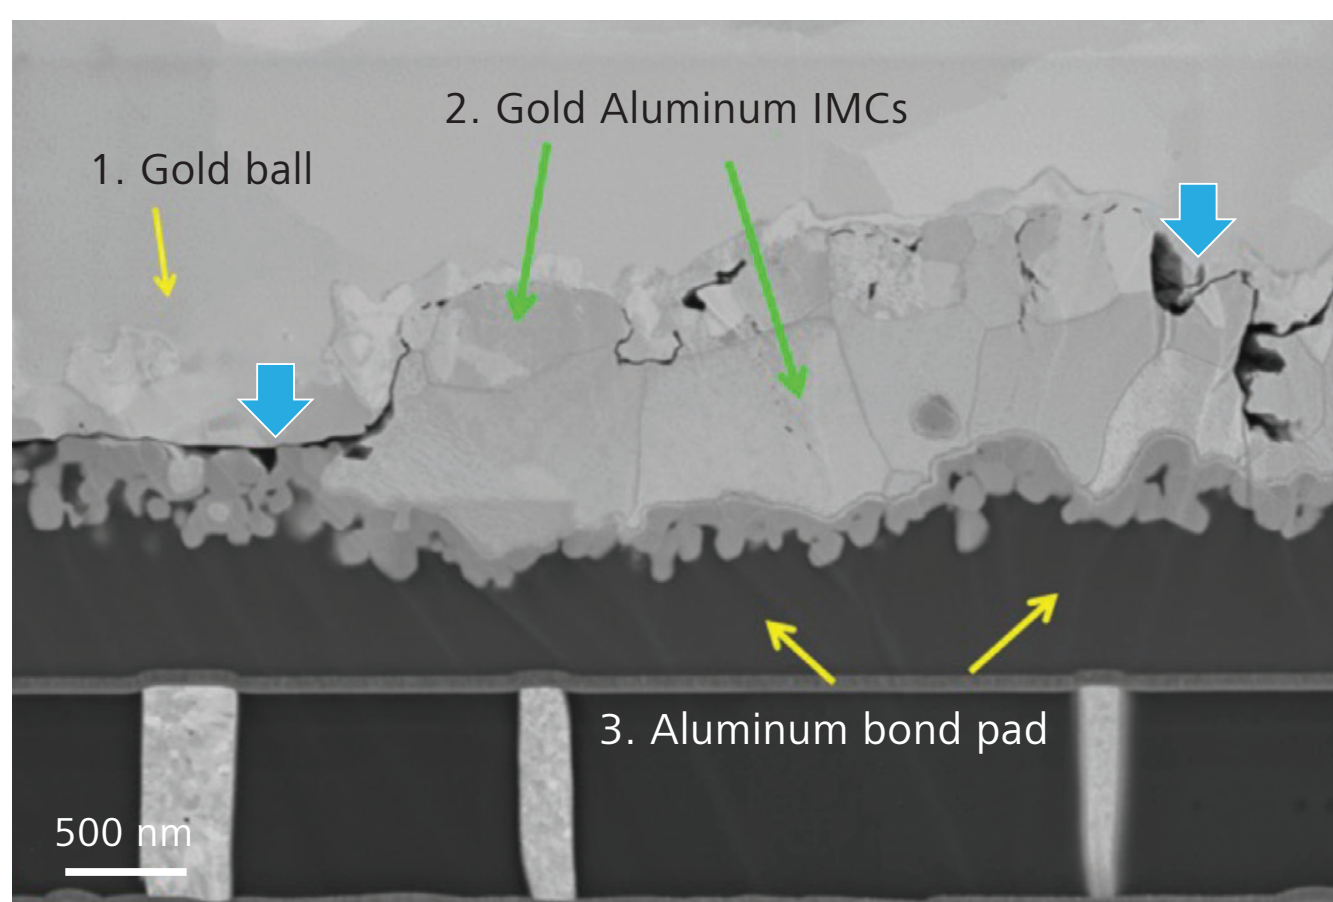
Figure 6 Ball bond between gold wire and aluminum bond pad. Several Au-Al intermetallic compounds (IMC) phases have formed. IMCs can change over time in response to elevated temperature (solid-state diffusion). In severe cases, solid-state changes can cause de-bonding and bond failure.

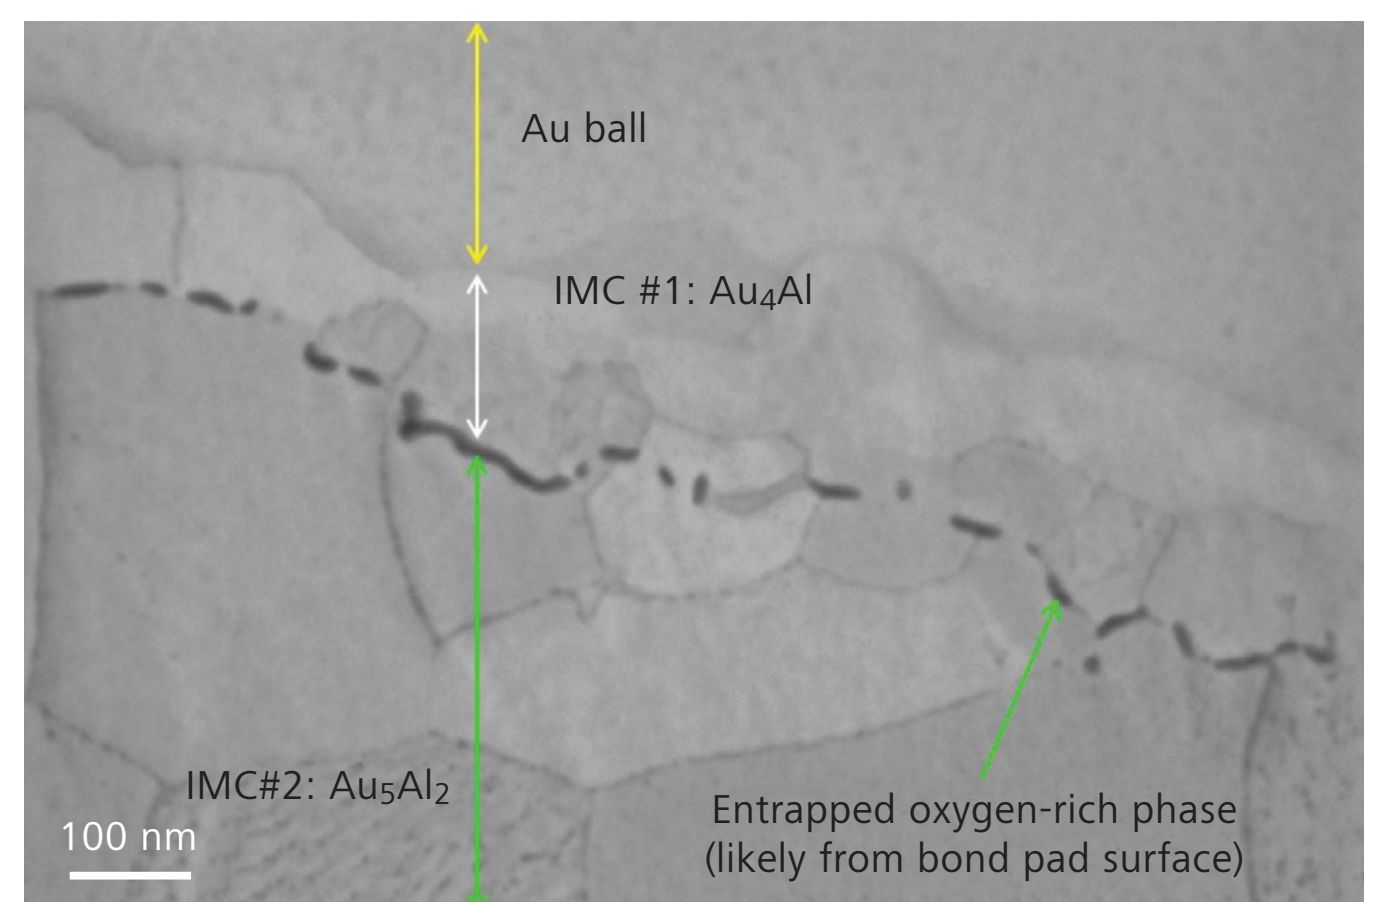
Figure 8 Part of a ball bond made between gold wire and aluminum bond pad. Two Au-Al IMC phases have formed with a thin layer of oxygen-rich material between the two IMC phases.

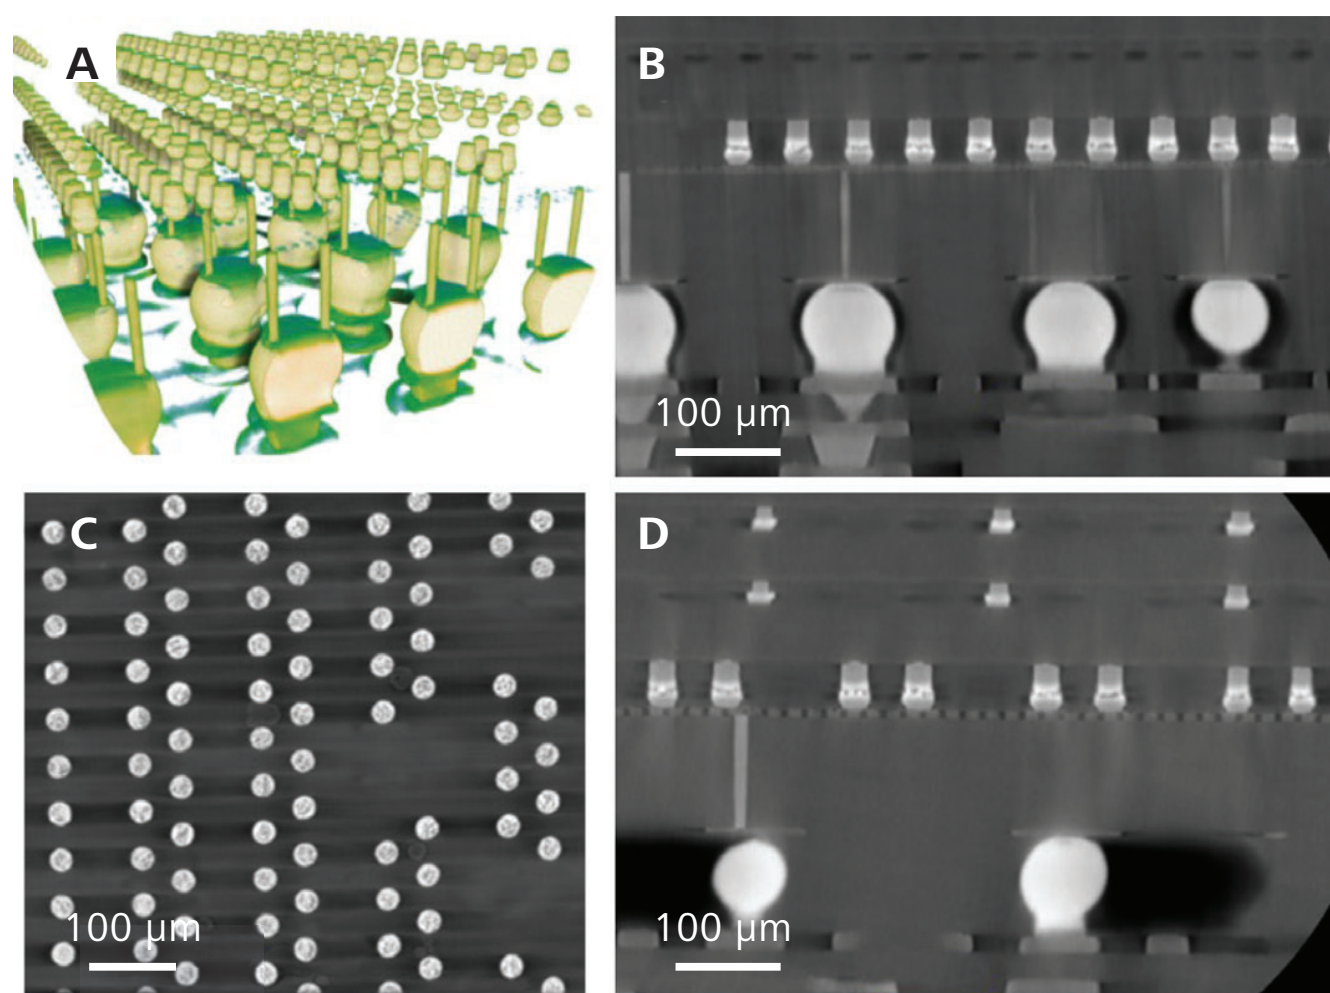
3D X-ray data was acquired with 90 kV energy at 0.7 µm/voxel resolution for the 2.5D package using XRM 4X optical objective. The fault region was microbump joint cracks at the interposer interface formed during thermal compression bonding process. The X-ray data clearly shows ~2 µm thick bump cracks in all three orientations (Figure 9b-d). With the information of the defect location in 3D to facilitate the sample preparation, physical cross-sectioning and SEM analysis followed to investigate possible root causes of the joint cracks. In this case, the Perfect Edge process was not employed. It is virtually impossible to do an accurate cross-section without the guidance of 3D X-ray data because the layer of the target microbumps are deeply buried, and therefore they are not visible by optical methods.

Figure 9 *3D X-ray tomographic images at 0.7µm/vox of the HBM 2.5D interposer package. A) 3D color-rendering image. B) Virtual slice shows the microbump layer between the Si interposer and HBM. C) planar view of the microbump layer. D) side view of the same layer of the microbumps.*

It is also not feasible to use the HBM bumps on the top layer as reference because they are not fully aligned with the target layer of microbumps in XY orientations (Figure 9d). To our best knowledge, XRM imaging is the only non-destructive technique which can reconstruct internal 3D structures of this package and provide sufficient resolution on the joint cracks.

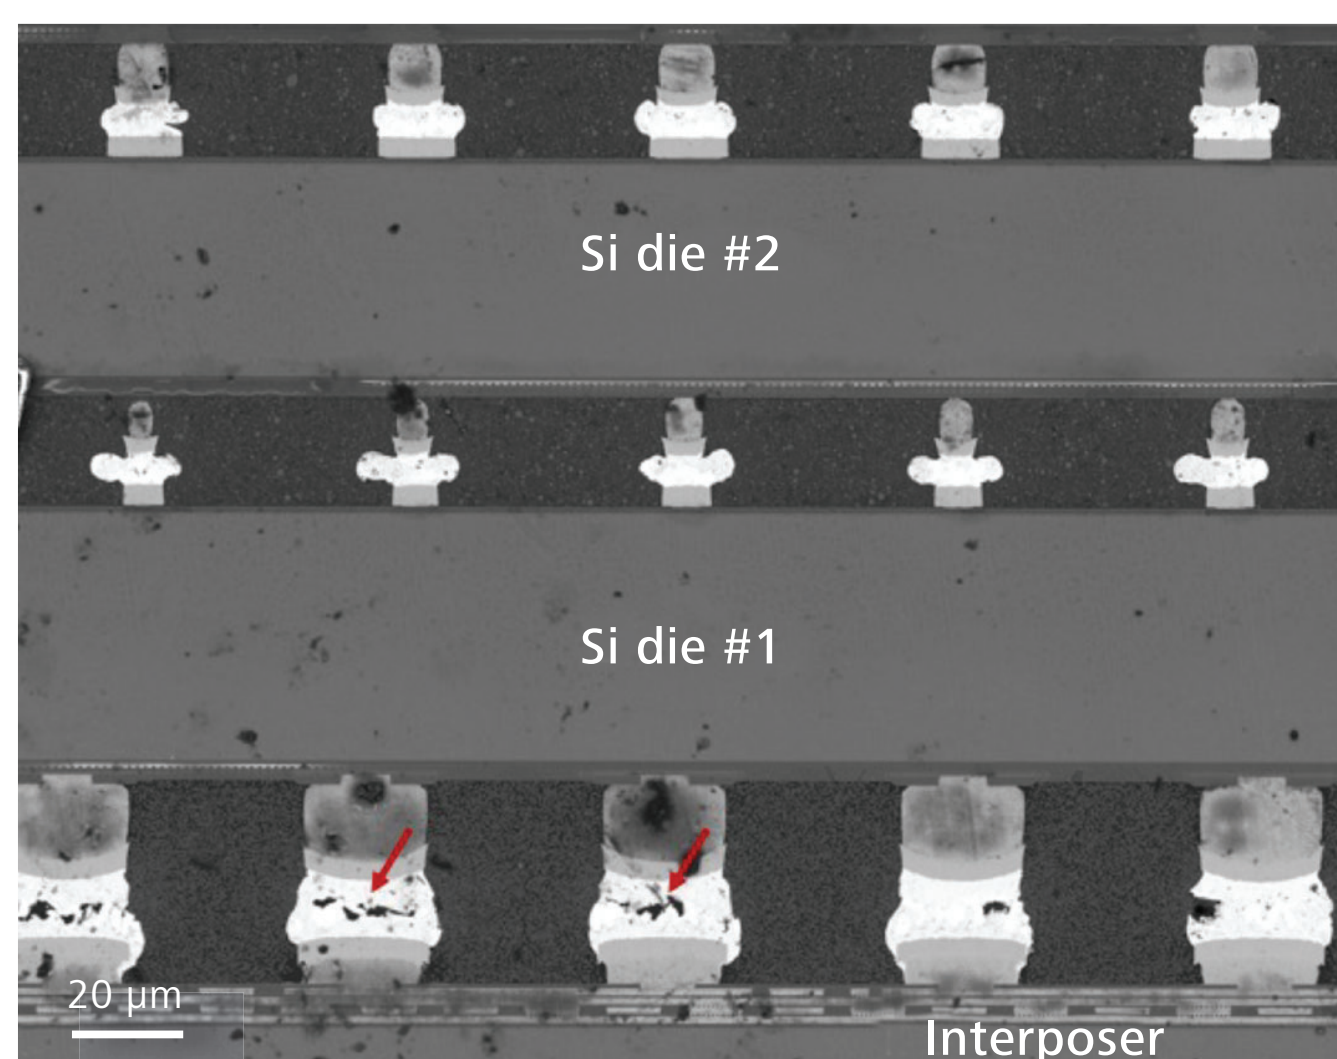
Figure 10 *Backscatter electron image of the microbump layer with two HBM die stacks on the top. The image was conducted with 5 kV acc. voltage at 86 nm/pixel.*

Figure 10 shows a backscatter electron microscope image of the target bump layer at the bottom of the micrograph. Conducting imaging at 5 kV accelerating voltage in high vacuum using the pixel size of 86 nm, the microbump joint cracks (indicated by red arrows) are clearly visible during the sample cross-sectioning through the center of the target microbumps. This image validates the existence of µbump micro-cracks observed in 3D XRM images. Figure 11 shows an individual microbump with solder joint cracks. It seemed that Ni pad layers and Cu pillars were intact without any sign of failure. Several intermetallic compounds (IMCs) phases were observed on the target microbump (Figure 11b).

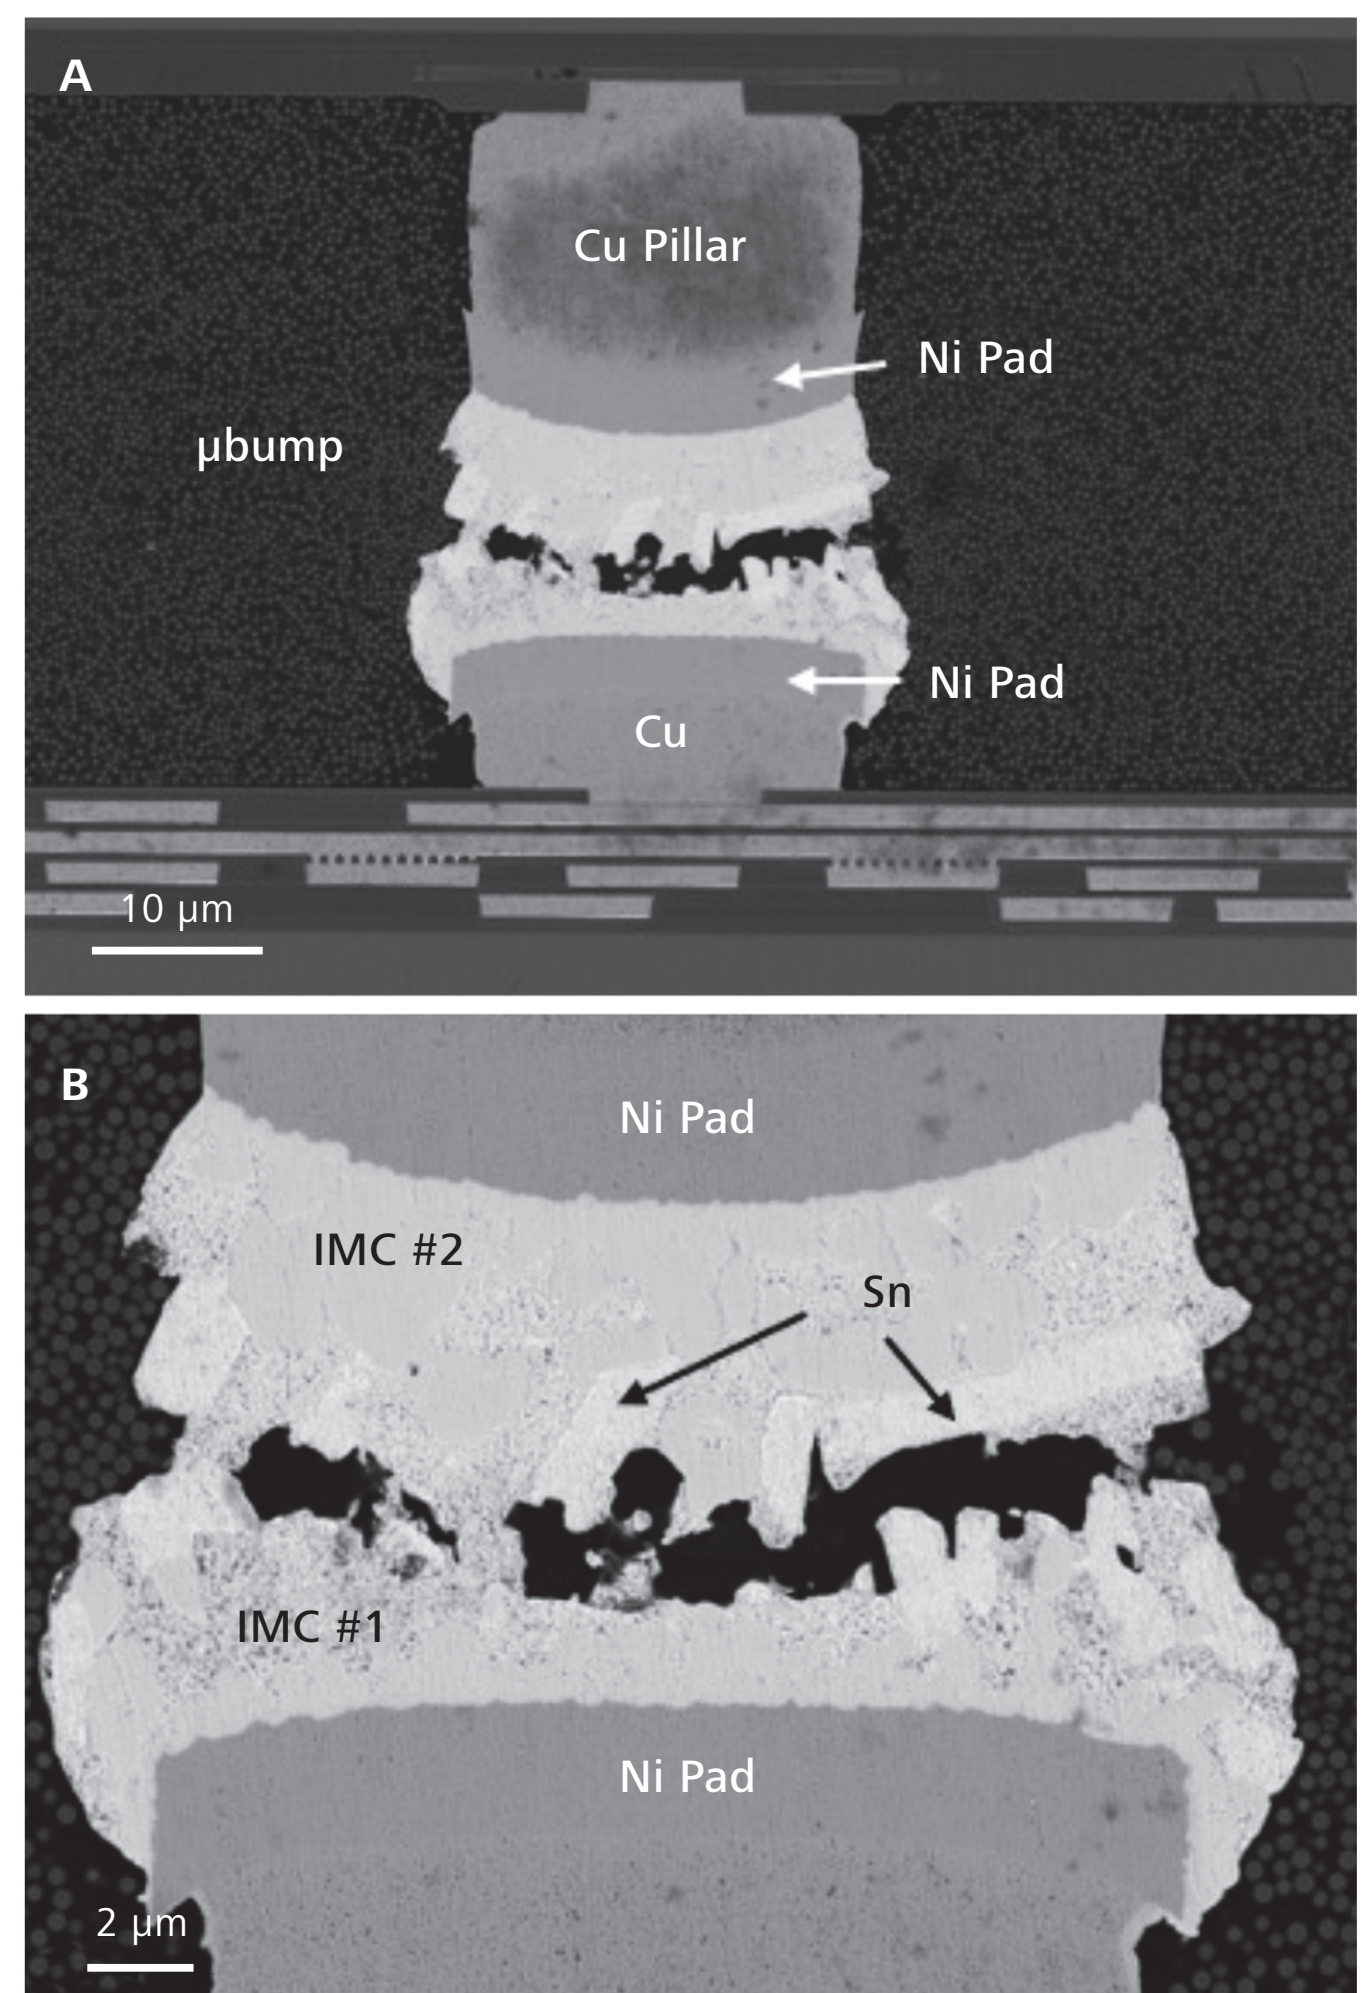
Figure 11 *Backscatter electron images of a microbump crack imaged at 5 kV acc. voltage with an annular backscatter detector. A) 37 nm/pixel; B) 15 nm/pixel.*

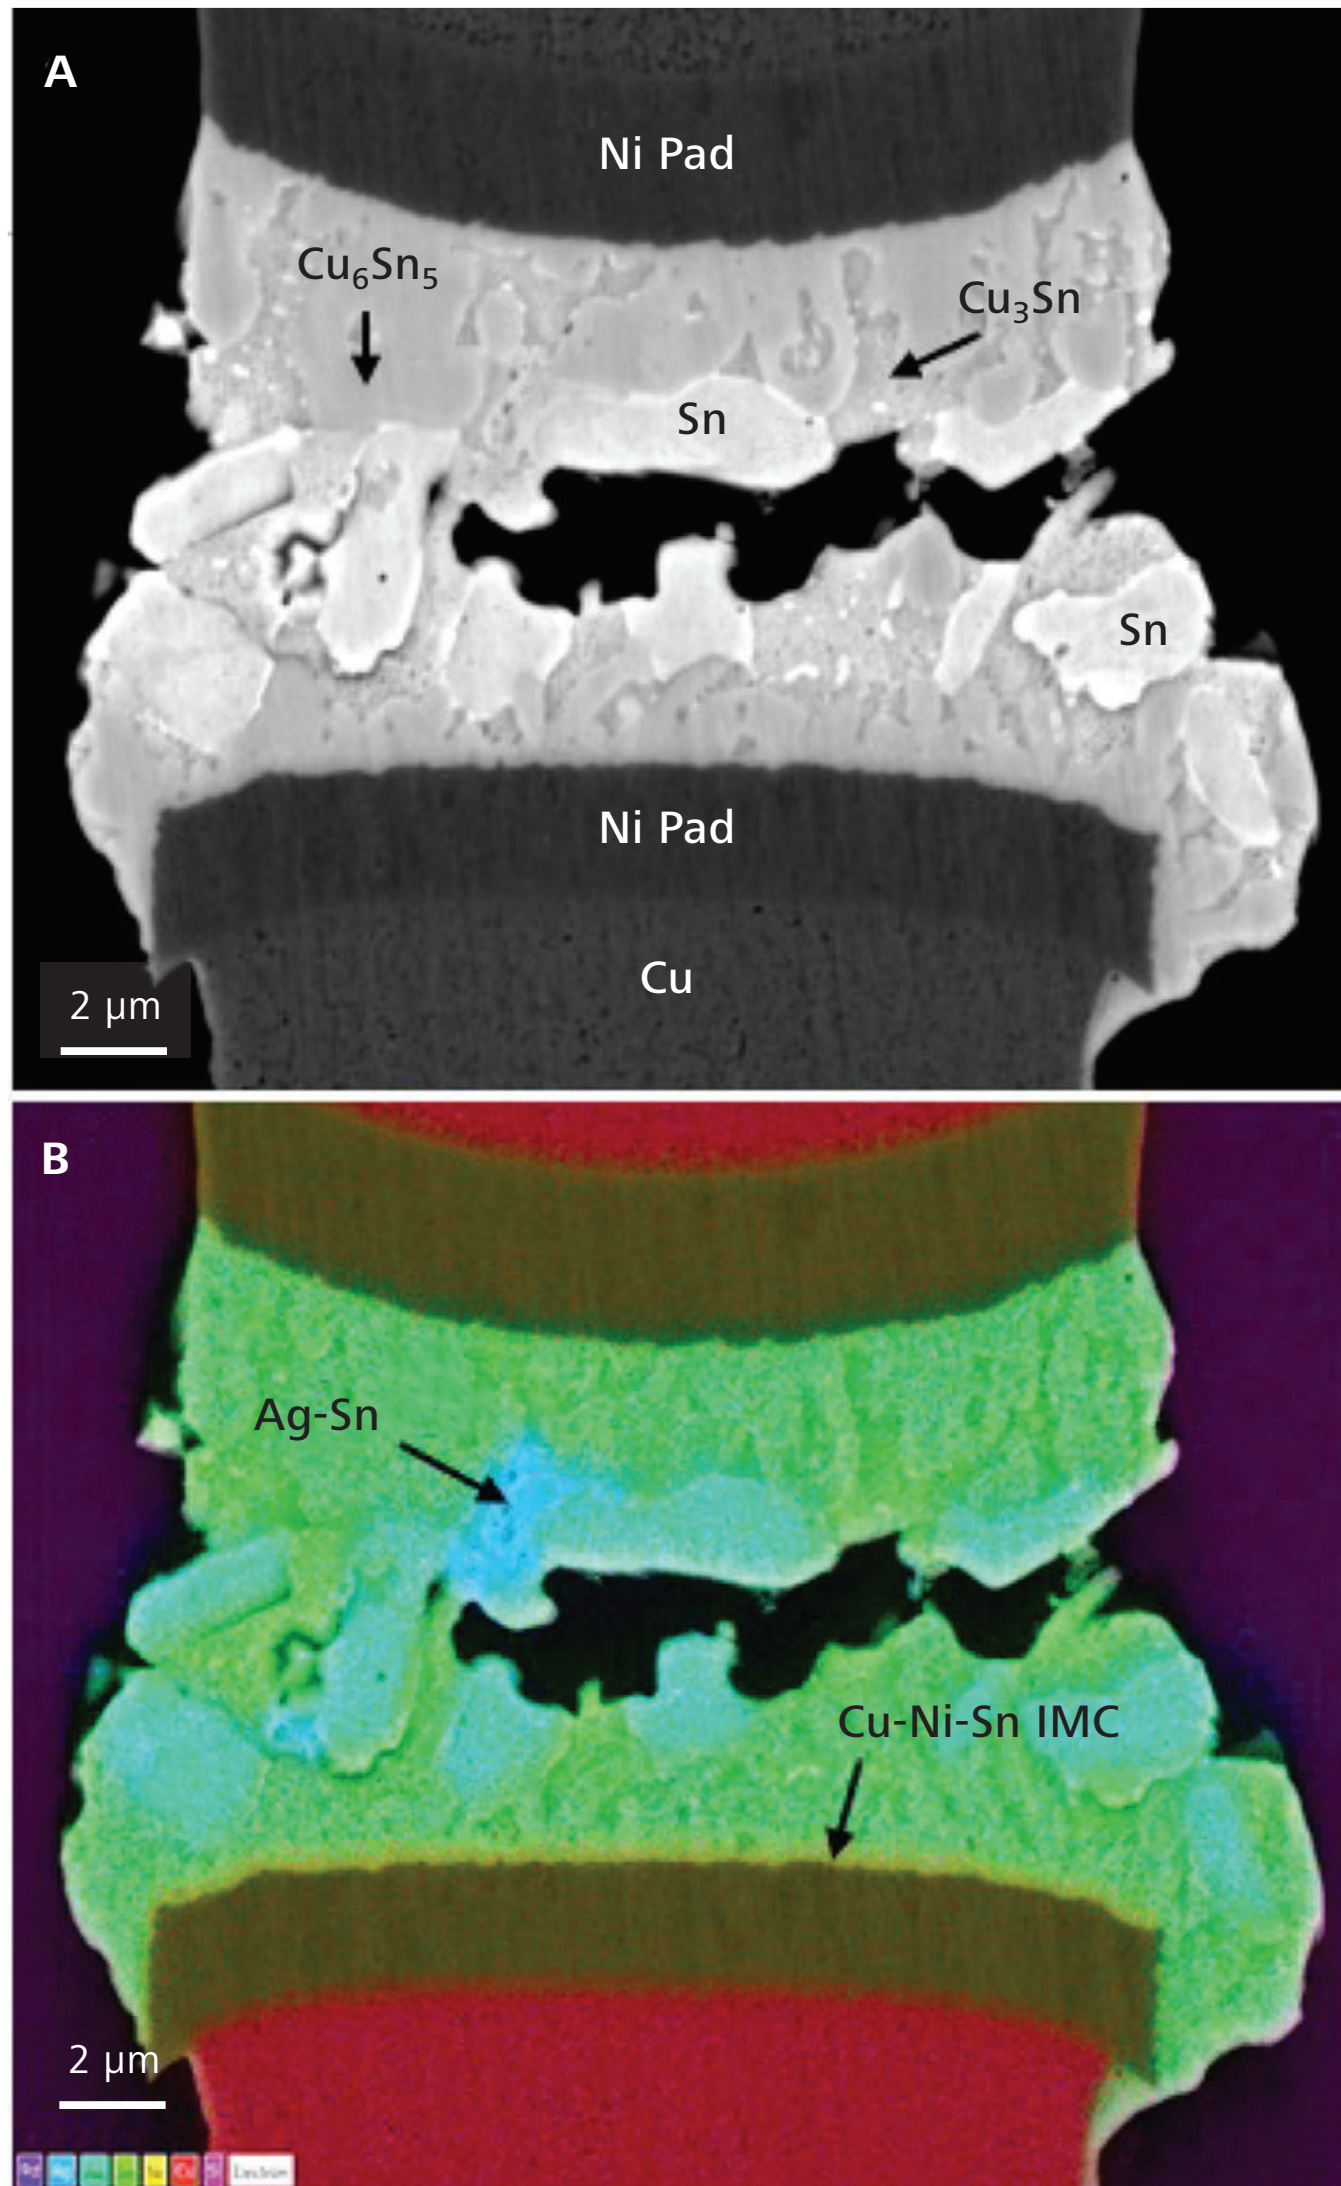
Figure 12 Backscatter electron image and energy dispersive X-ray spectroscopy (EDS) elemental map of a cracked microbump with distinct metal phases in the solder and solder mask. The pixel size is 31 nm.

The backscatter image in Figure 12a and the EDS elemental map image in Figure 12b show the cracked microbump with several metal phases in the solder materials. Analytical imaging conditions were 17 kV accelerating voltage with 3 nA beam current at a working distance of 8.5 mm, map live time 576 seconds using an EDS detector. We were able to identify the different IMC phases formed during thermal compression bonding assembly. Based on the X-ray data, SEM images, and EDS information on the bump metallurgy, we concluded that the large interposer warpage is likely to generate sufficient shear force on the microbump layer, leading to the crack formation and propagation. There was no other metallic abnormality observed in this case.
